S11 / S11 MMI

Repair Documentation

Level 2.5

V 1.2

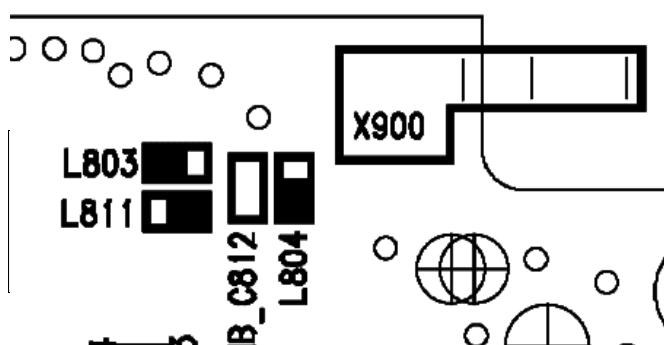
Figure 2: S11 Antenna Spring (X900) Placement (Top View)

The GSM-Tester will show a low Tx-Power only on the *internal* antenna (aerial coupler measurement!).

Visually check the status of the antenna spring. Look for a bent contact or dry soldering joint.

Use soldering iron to remove defective spring.

Resolder new spring afterwards.

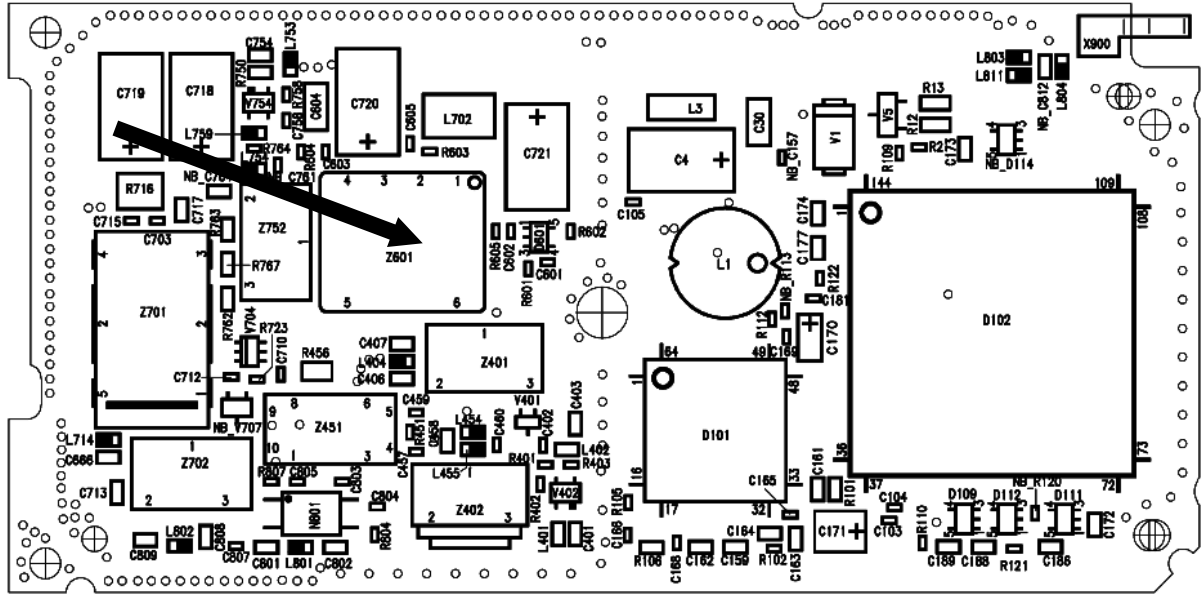
Figure 1: S11 Board TCXO Side

Frequency error in synchronized mode >90 Hz
No location update possible

If the frequency error is higher than 2kHz, the TCXO has to be replaced.

Use hot air blower to remove defective TCXO.

Resolder new TCXO afterwards.

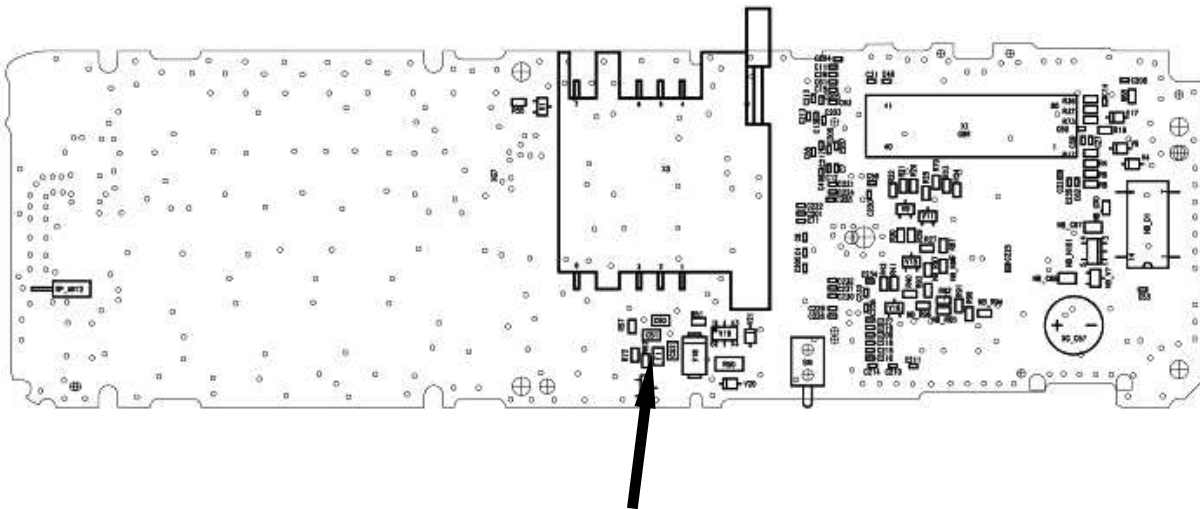
Figure 1: S11 MMI Board 1A Fuse Side

Battery charging not possible

a multimeter. The fuse is defective if the resistance higher than 10 ohms

Use soldering iron to remove defective fuse.
Avoid excessive heat!
Watch surrounding components!

Resolder new fuse afterwards.

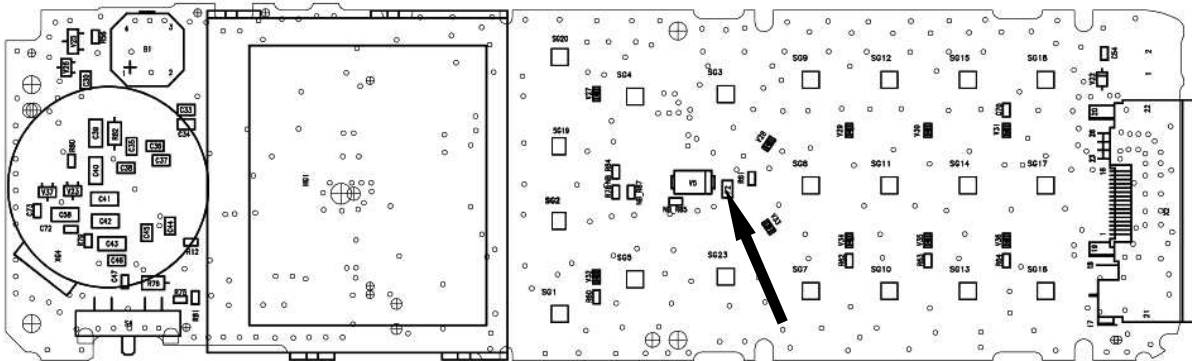
Figure 1: S11 MMI Board 0.25A Fuse Side

Supplying of external accessories through the handset's bottom connector is not possible

Check the status of the fuse by measuring its resistance with a multimeter. The fuse is defective if the resistance is higher than 10 ohms

Use soldering iron to remove defective fuse.
Avoid excessive heat!
Watch surrounding components!

Resolder new fuse afterwards.

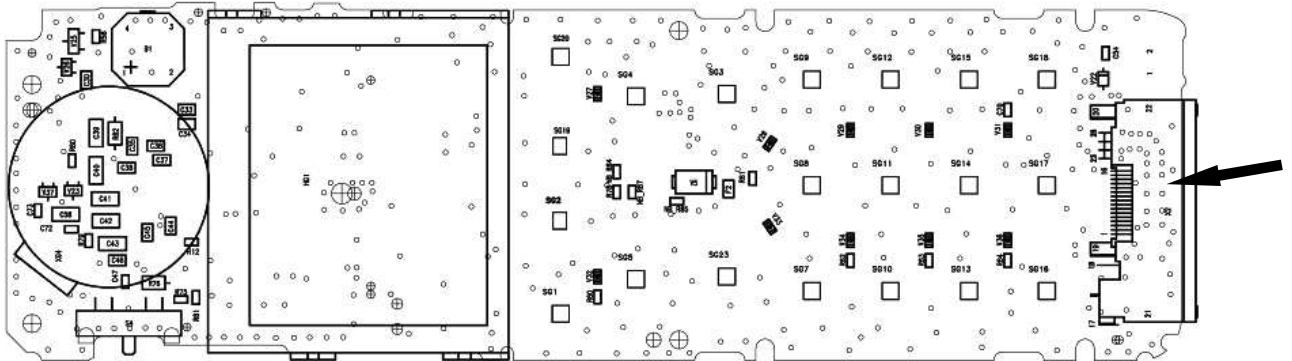
Figure 1: S11 MMI Board Bottom Connector Side

Charging or operation in a car kit not possible.

Visually check the bottom connector. Watch for dry joints.

Use hot air blower to remove defective connector.
Avoid excessive heat!
Watch surrounding components!

Resolder new connector afterwards.
Make sure that you use just very little flux, otherwise the connector contacts can become dirty.

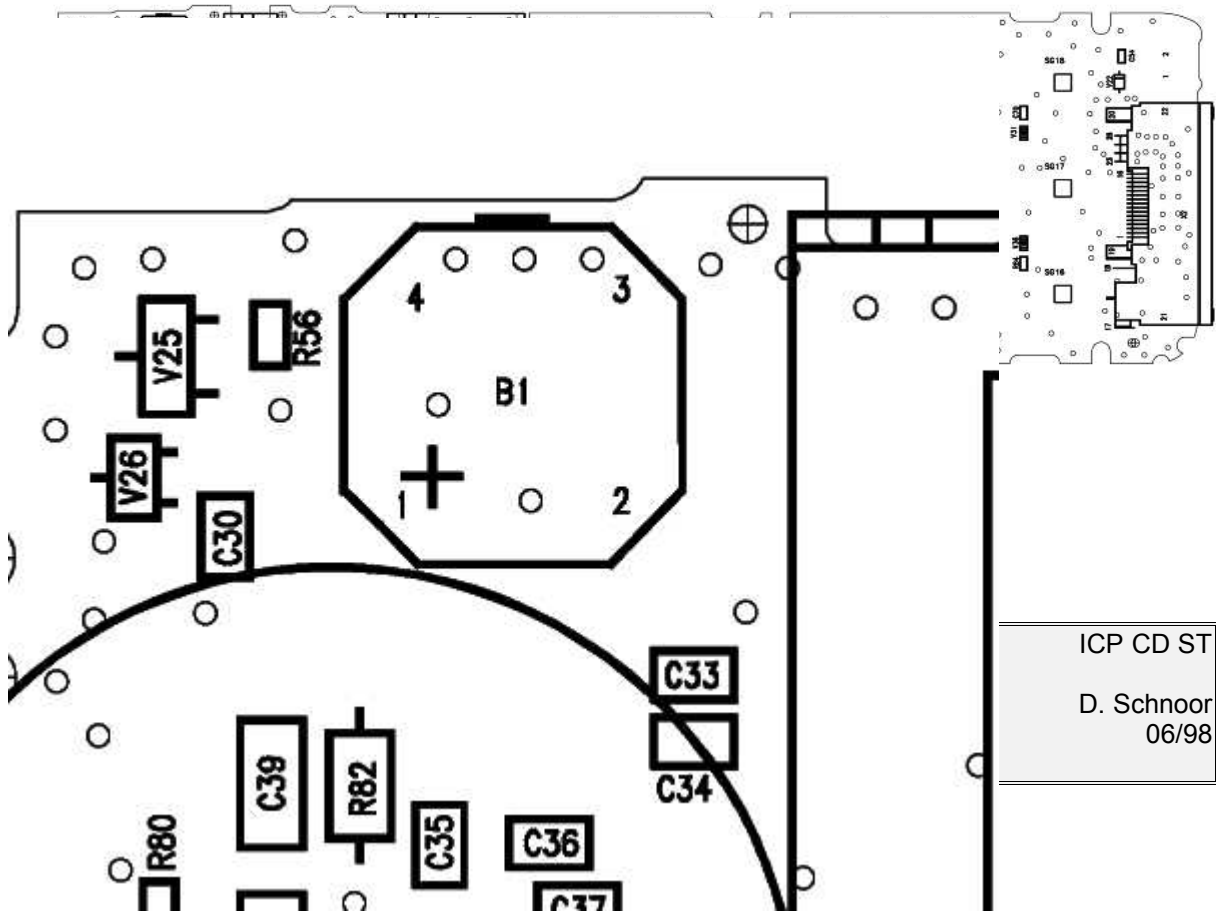
Figure 1: S11 MMI Board Ringer Side

No ringer tone audible or ringer tone distorted.

Use hot air blower remove defective ringer.
Avoid excessive heat!
Watch surrounding components, especially the display window!
To protect the display, you can also desolder the ringer with solder wick.

Resolder new ringer afterwards.
Watch placement of ringer!

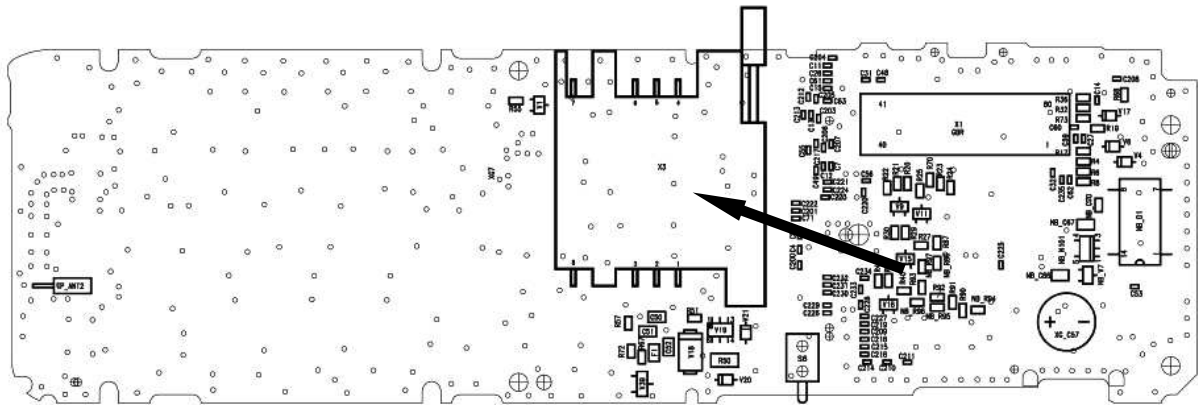
Figure 1: S11 MMI Board Cardreader Side

Sim card is not accepted or properly read by
the handset.
Sim card ejection mechanism may be damaged.

Check cardreader functionality with sim card.
Attention: Watch for dry joints (especially pin 7!) or mechanical damage.

Resolder dry joints.

If the cardreader is mechanically damaged use solder wick to remove defective component.
Avoid excessive heat!
Watch surrounding components!!

Resolder new cardreader afterwards.

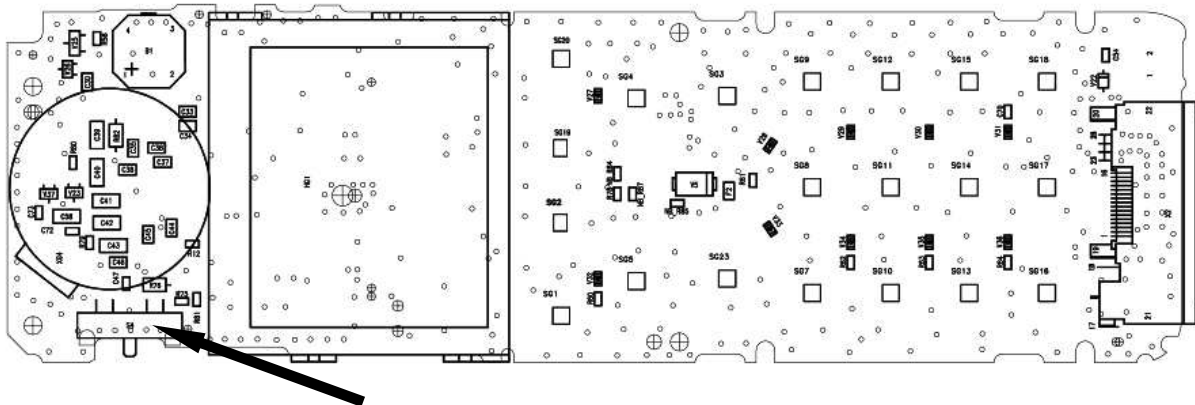
Figure 1: S11 MMI Board Volumeslider Side

The volume slider does not work properly.

Check volumeslider functionality either manually or with the testing program.
Watch for dry joints or mechanical damage.

Use solder wick to remove defective slider.
Avoid excessive heat!
Watch surrounding components!!

Resolder new volumeslider afterwards.

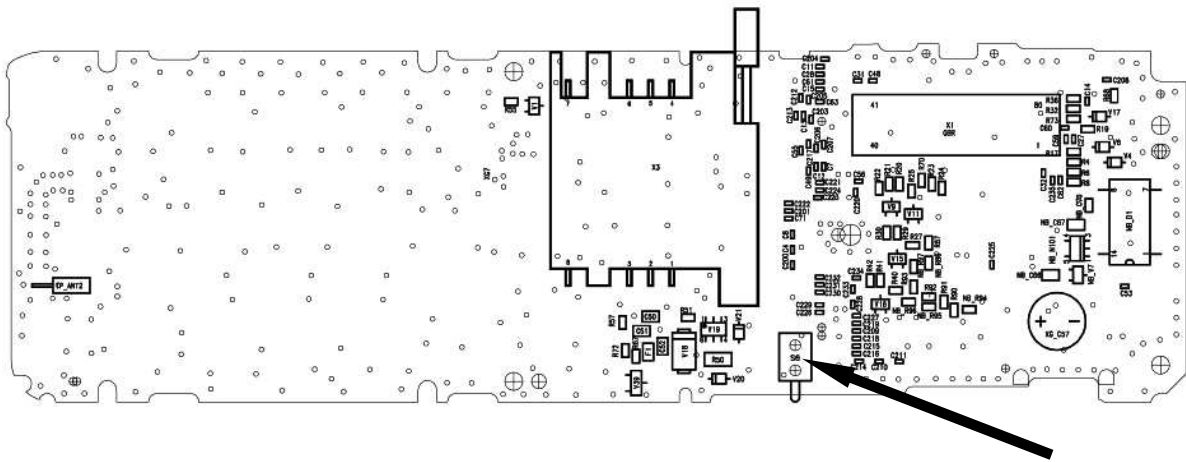
Figure 1: S11 MMI Board Memoswitch Side

The memoswitch does not work properly.

Watch for dry joints or mechanical damage.

Use solder wick or hot air to remove defective switch.

Resolder new memoswitch afterwards.

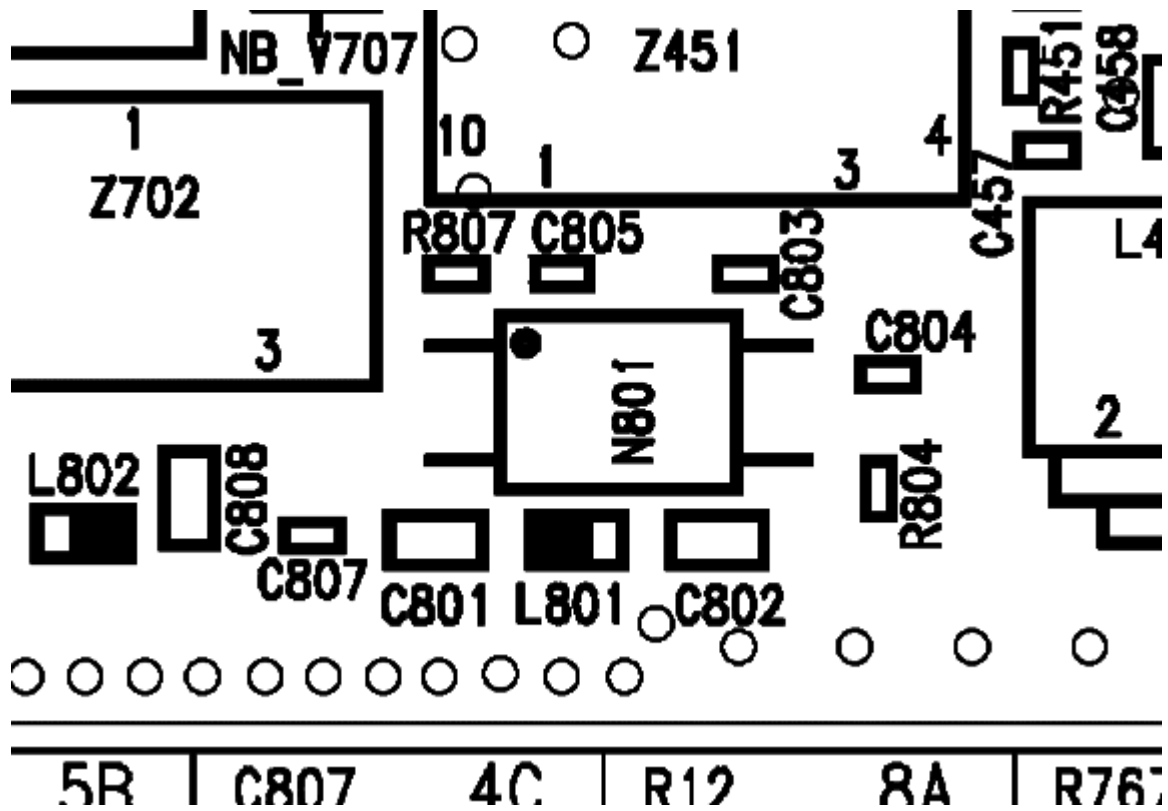
Handset fails with low Tx power on both or either
antenna.
No location update possible.

Pin 2 and 7 against ground must be around 86 kOhms.

If any of these resistances are significantly different, the antennaswitch will have to be replaced.

Use solder wick or hot air to remove defective switch.
Avoid excessive heat!
Watch surrounding components!!

Resolder new antennaswitch afterwards.
